# **Dam Safety Assessment of CCW Impoundments**

## **GenOn/NRG CHESWICK POWER STATION**

November 6, 2013

**O'BRIEN & GERE**  
[www.obg.com](http://www.obg.com)

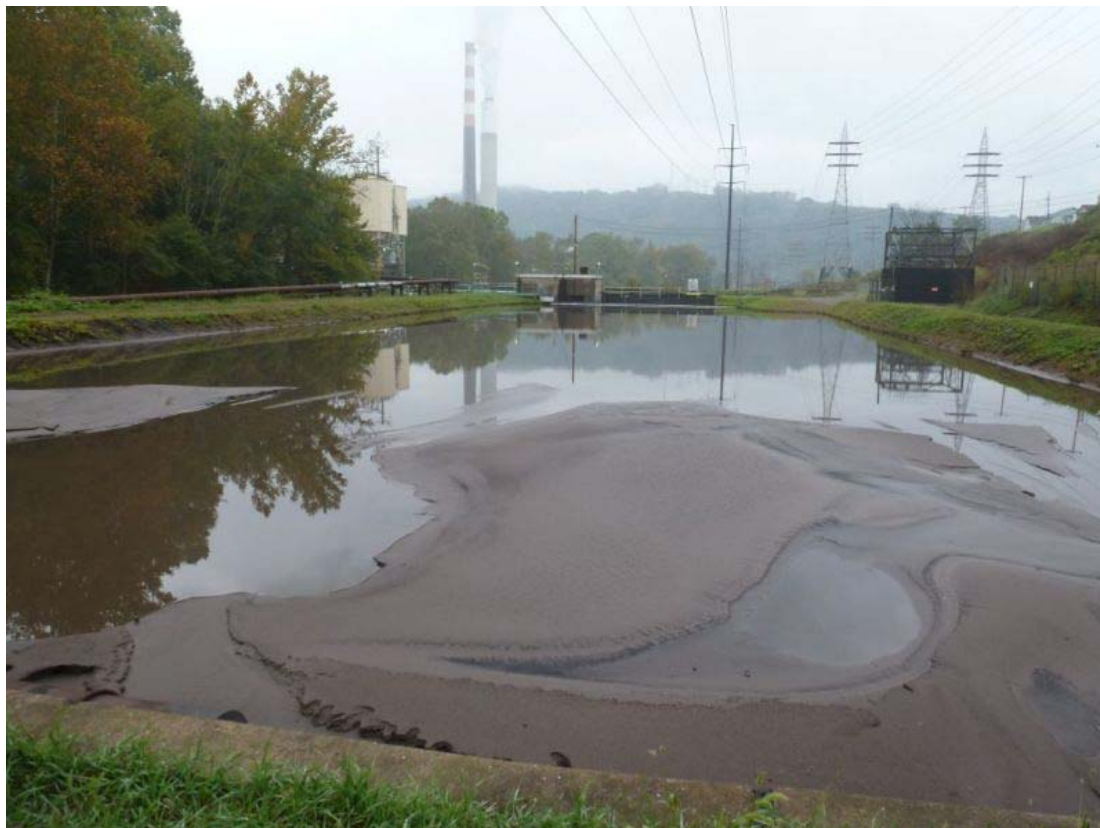
Orientation:  
SouthDescription:  
Bottom Ash  
Recycle Pond  
303, bottom  
ash solids in  
foreground.

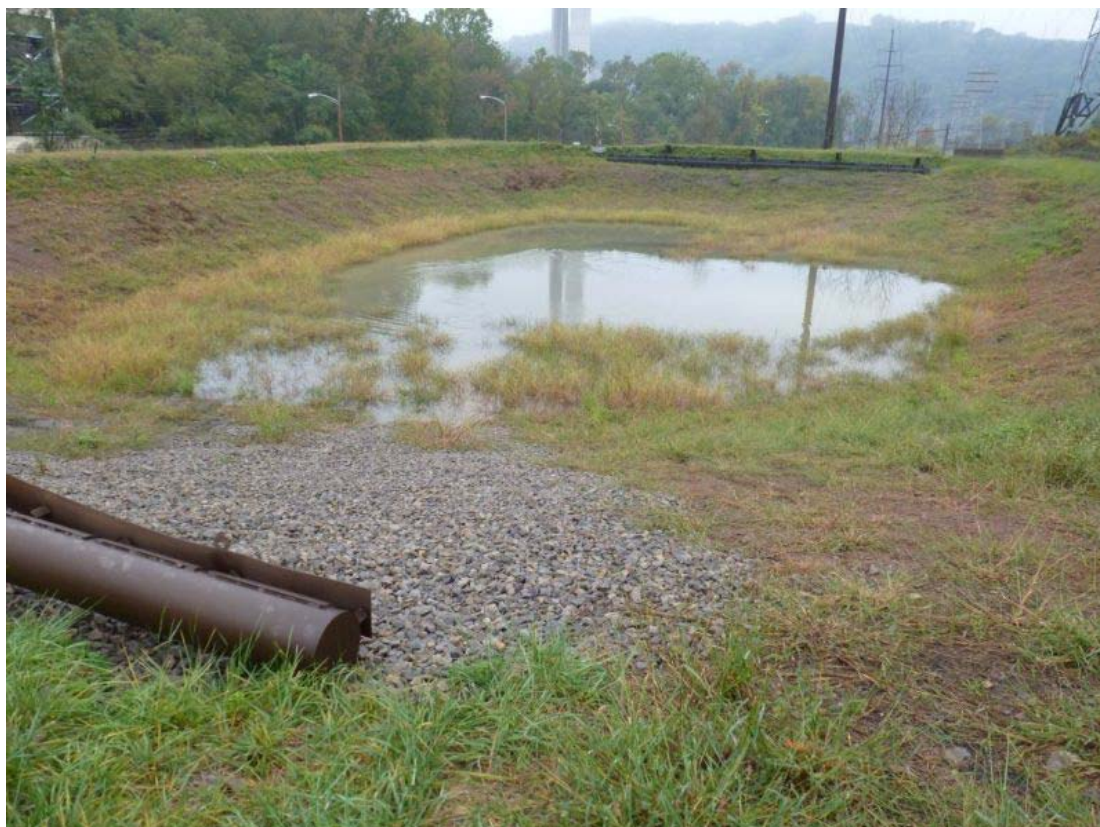
Date:  
9/27/12Photo Number:  
1Photographer:  
DDWOrientation:  
SoutheastDescription:  
Emergency Ash  
Pond 203, not  
in operation,  
inlet in  
foreground,  
outflow weir in  
background.

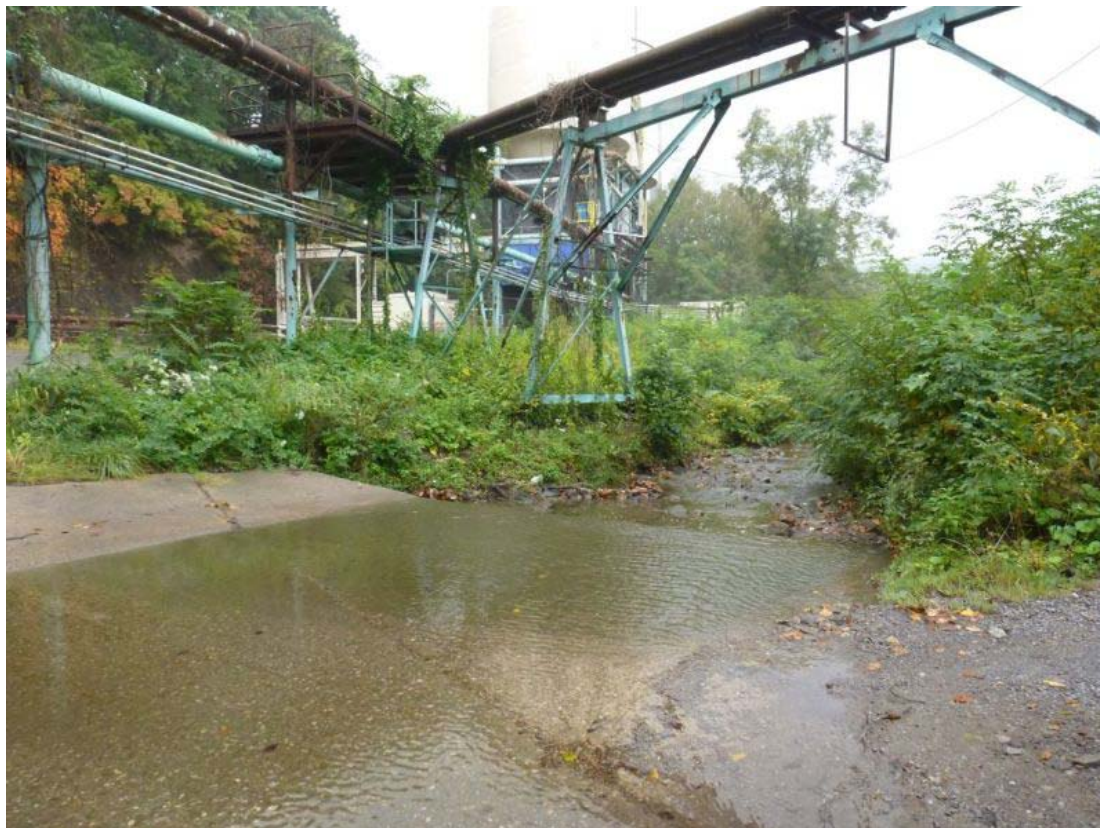
Orientation:  
SoutheastDescription:  
Tawney Run in foreground, hydrobins in background, elevated pipes leading to and from ash ponds.

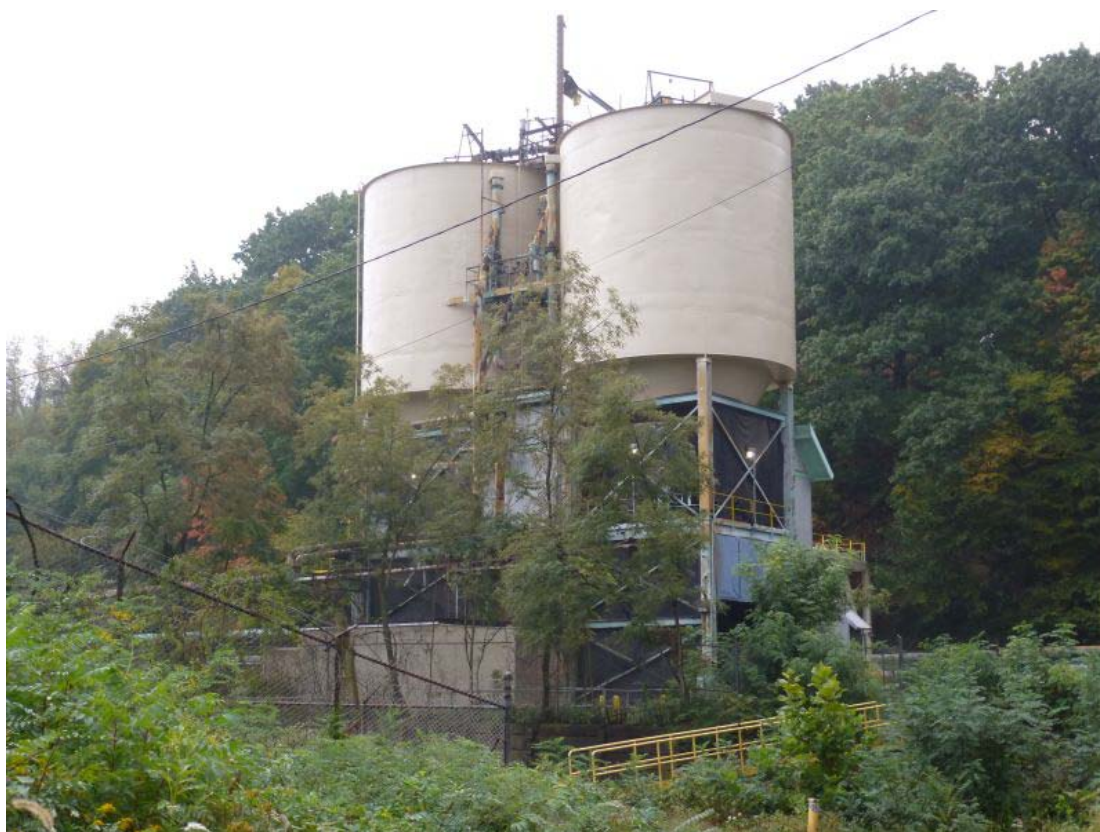
Date:  
9/27/12Photo Number:  
3Photographer:  
DDWOrientation:  
NortheastDescription:  
Hydrobins.

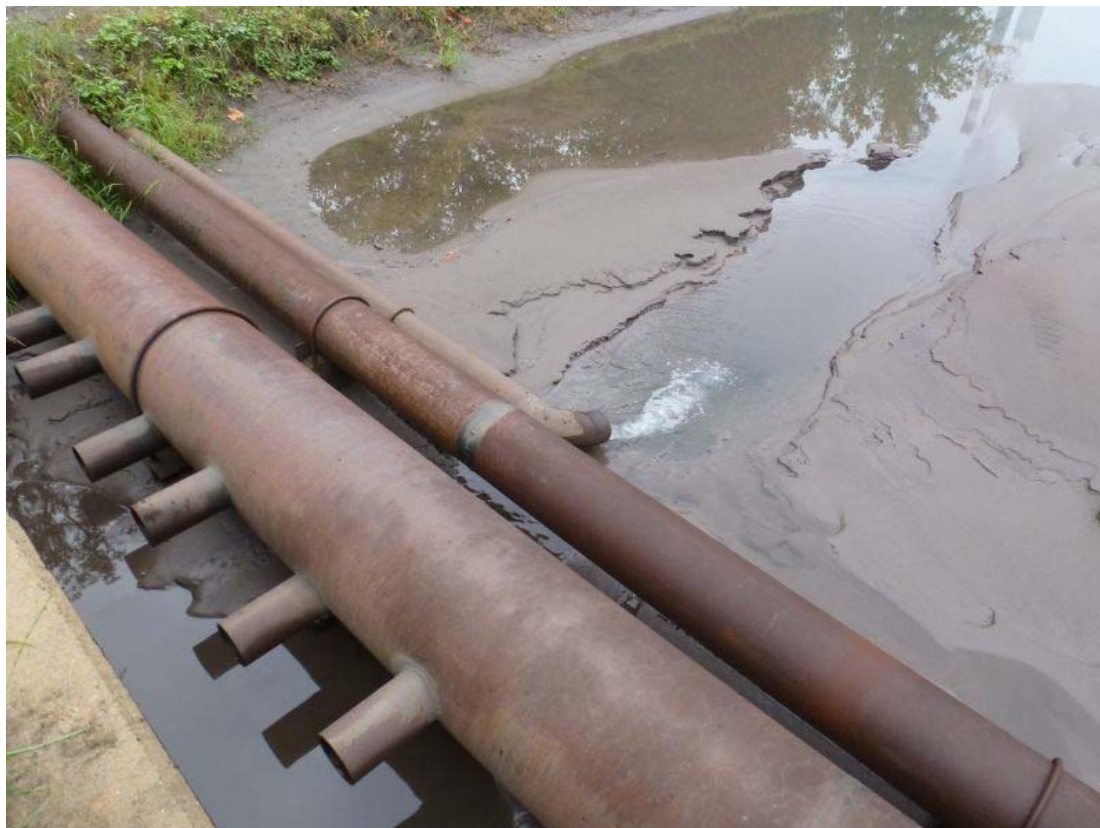
Photo Number:  
5

Description:  
Bottom Ash  
Recycle Pond  
303 inflow area  
and pipes.

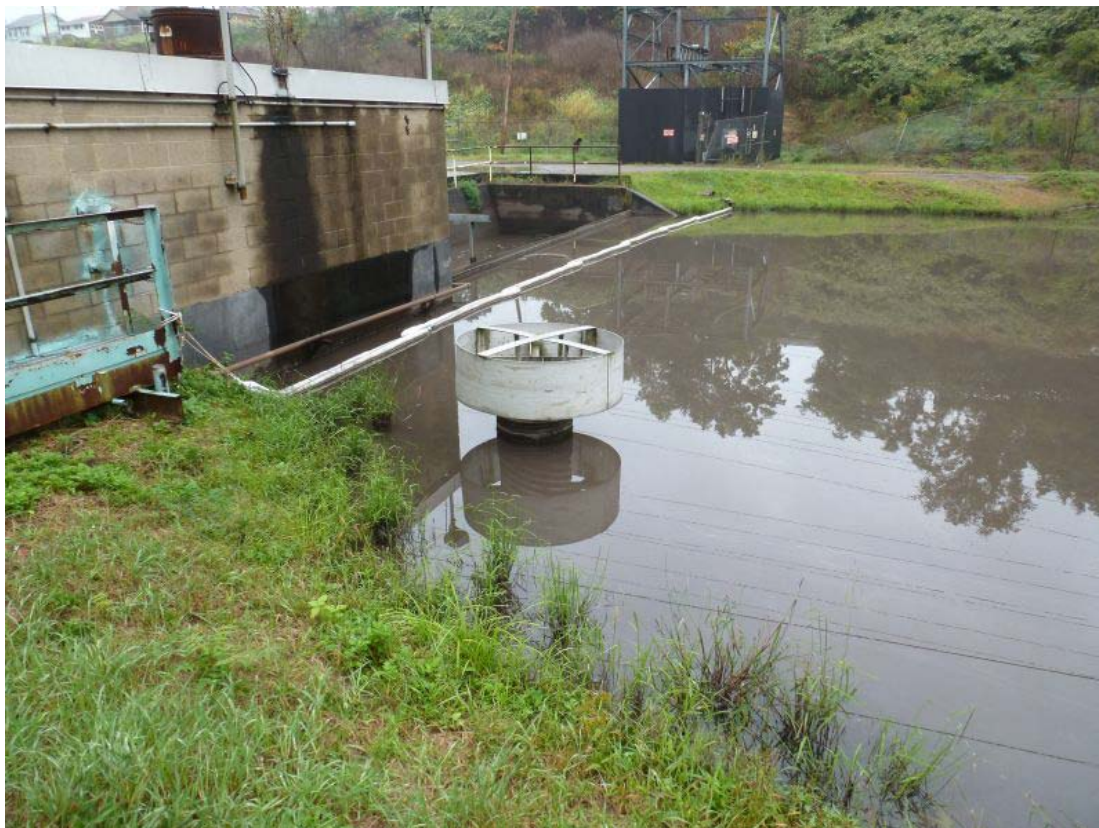
Orientation:  
SouthwestDescription:  
Bottom Ash  
Recycle Pond  
303 outflow  
weir and pump  
house.

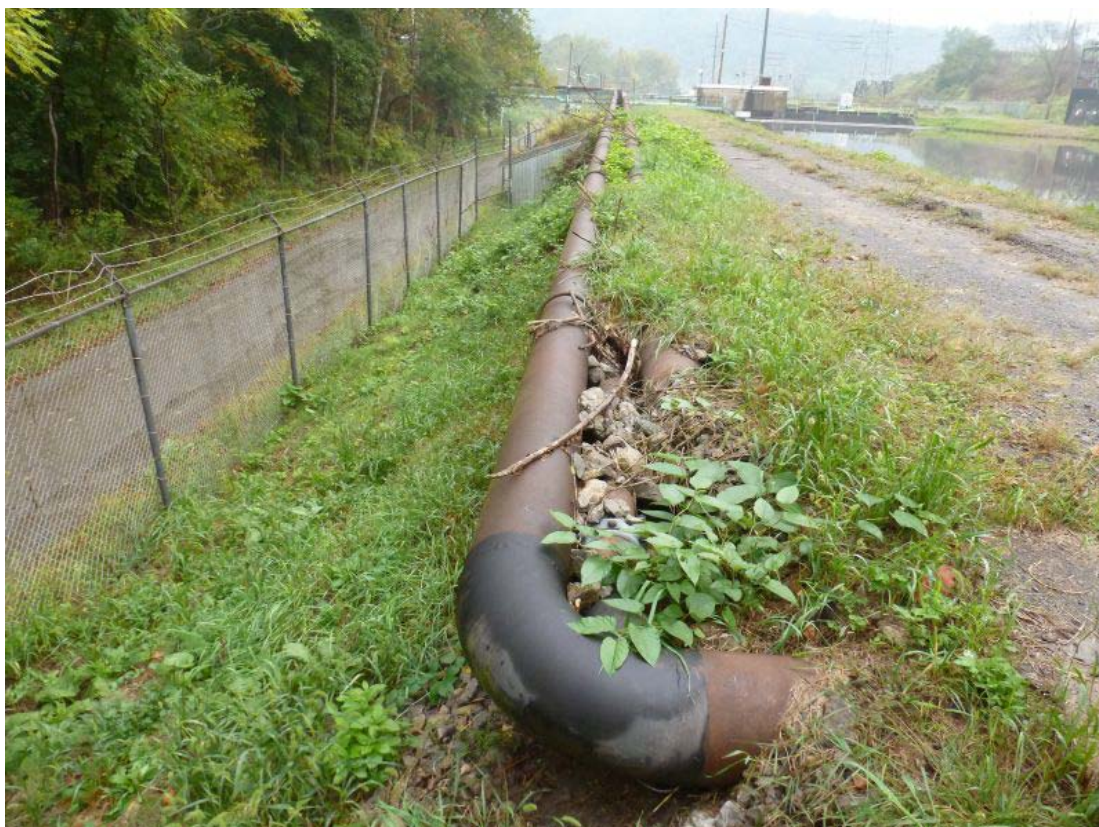
Date:  
9/27/12Photo Number:  
7Photographer:  
DDWOrientation:  
SouthDescription:  
Bottom Ash  
Recycle Pond  
303 eastern  
embankment,  
intake pipes,  
access road,  
and security  
fence.

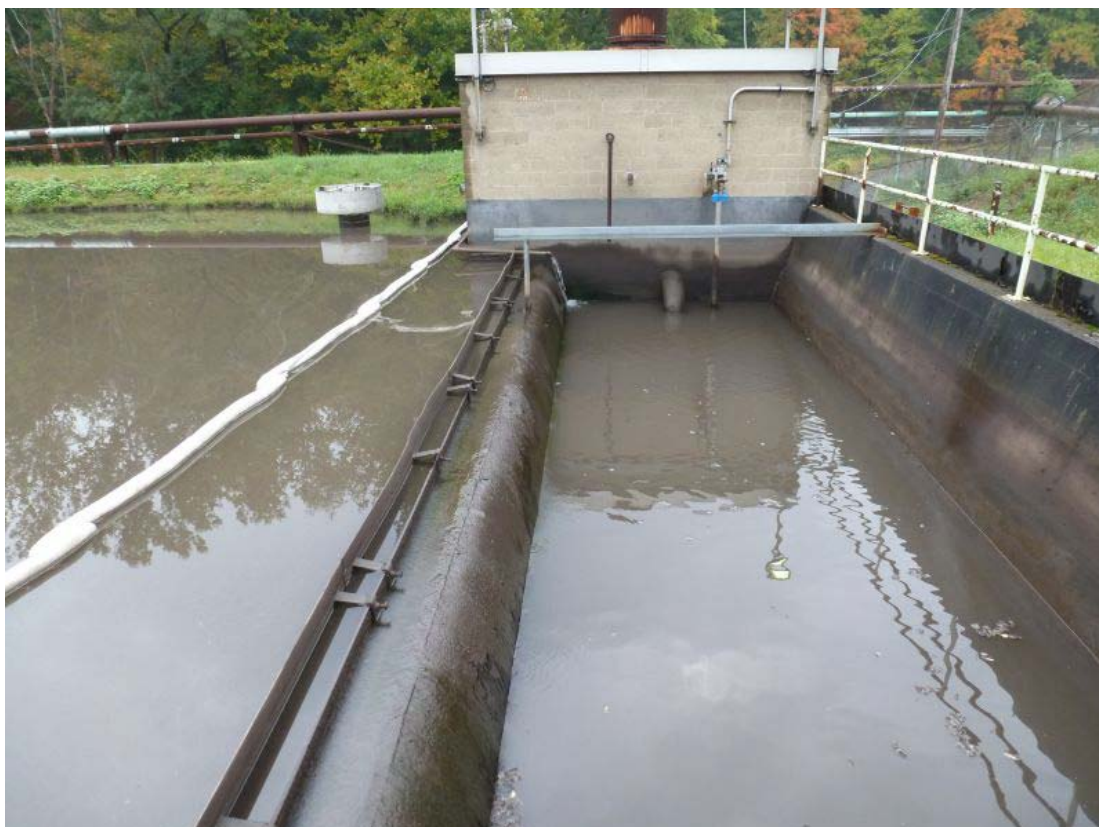
Description:  
Bottom Ash  
Recycle Pond  
303 outflow  
weir and stilling  
basin, pump  
house in  
background.

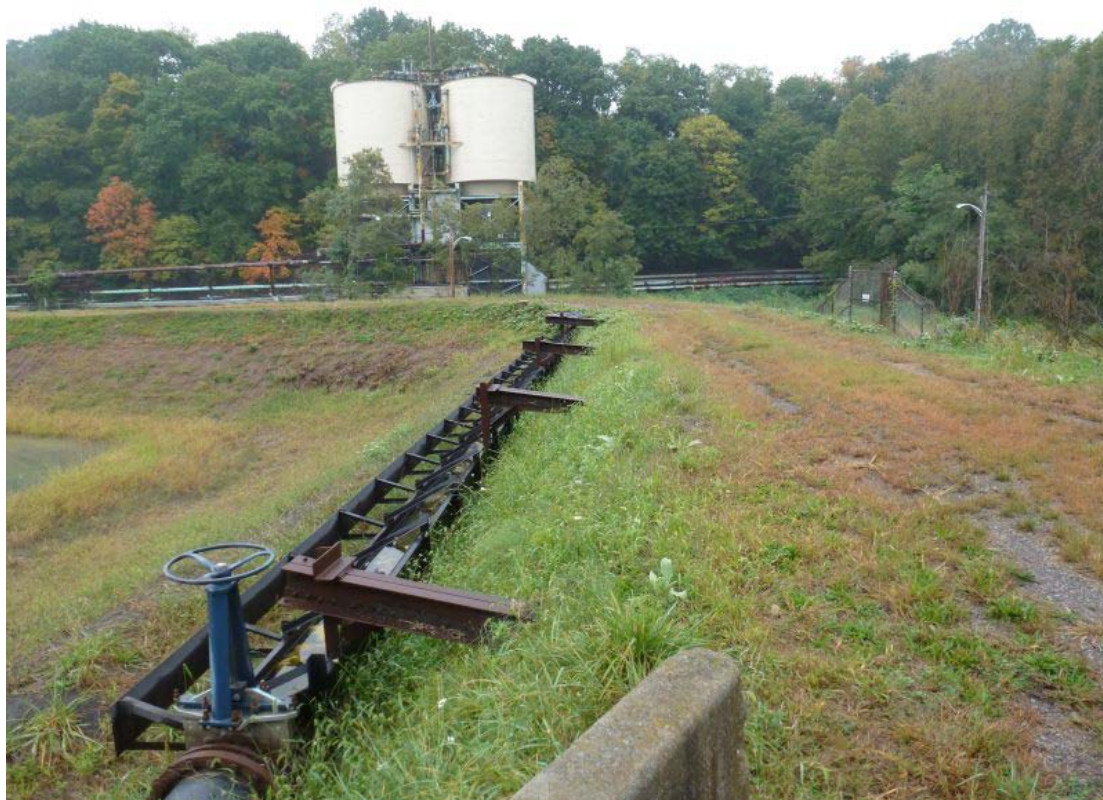
Description:  
Emergency Ash  
Pond 203  
outflow  
structure,  
southwest  
corner inboard  
slope, and  
south  
crest/access  
road.  
Hydrobins in  
background.

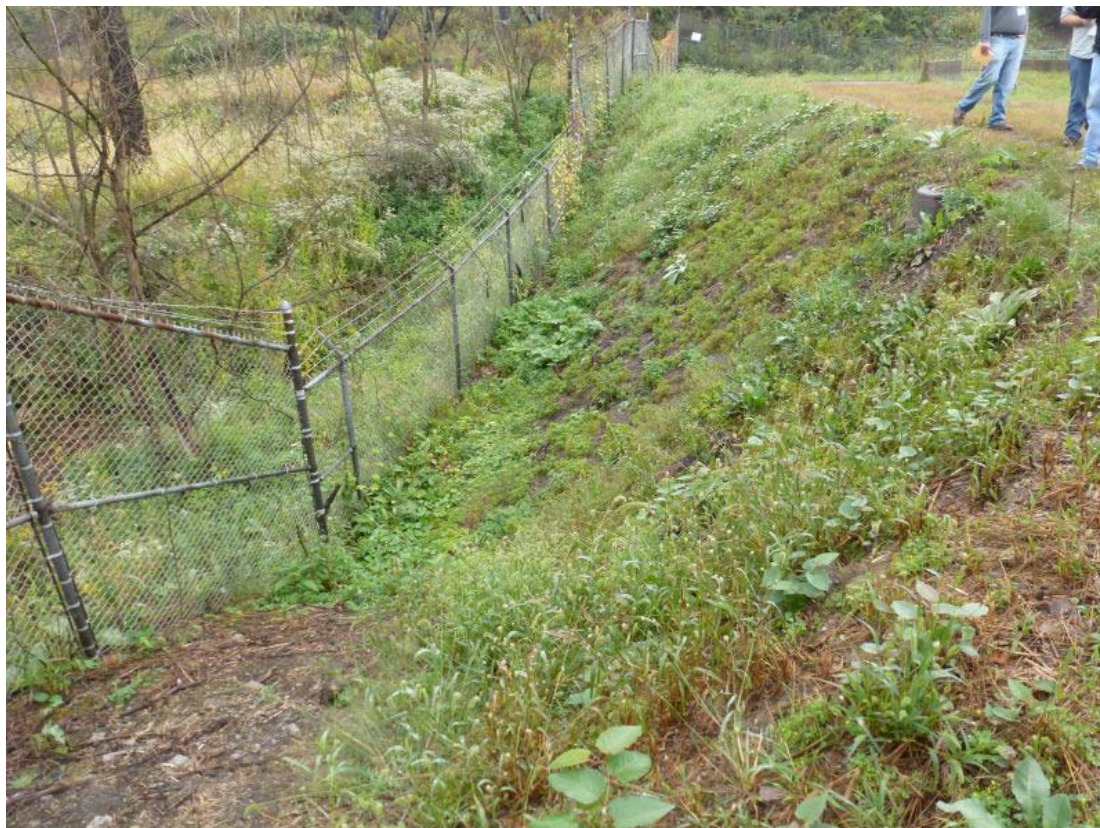
Emergency Ash  
Pond 203  
southern  
embankment.

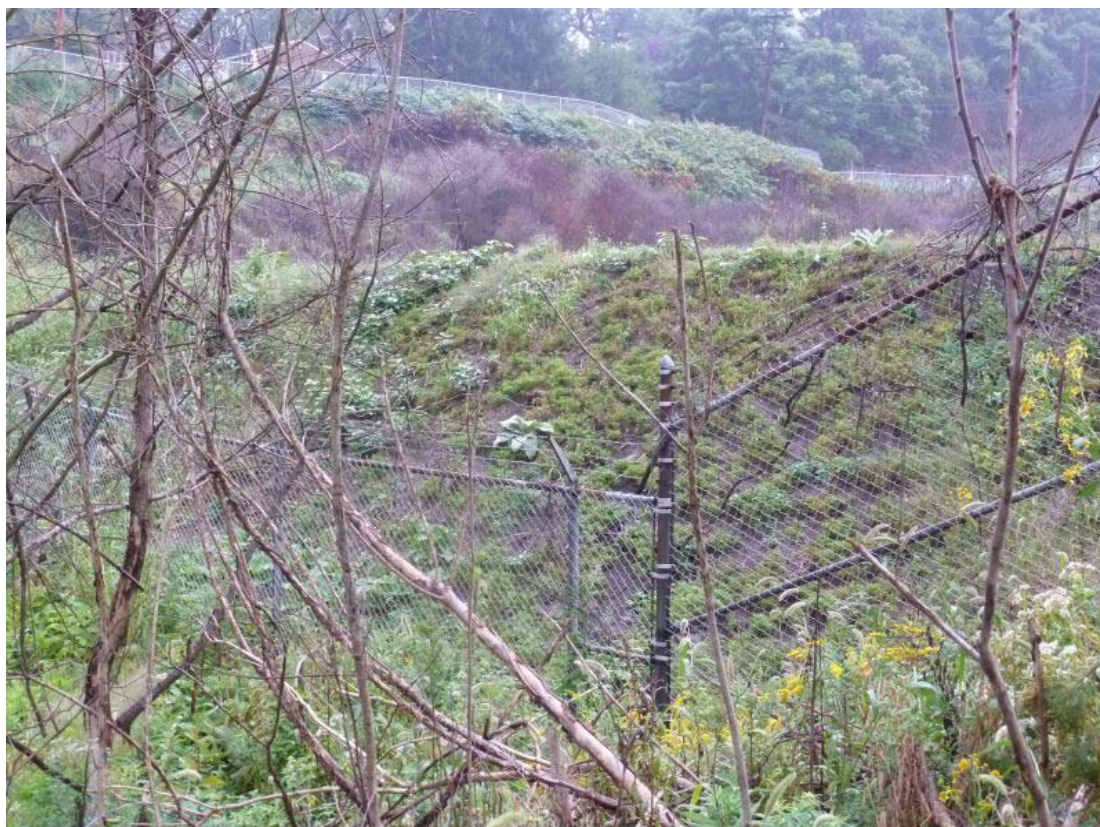
Emergency Ash  
Pond 203  
southern  
embankment  
behind fence in  
foreground.  
Natural hillside  
west of ash  
ponds in  
background.

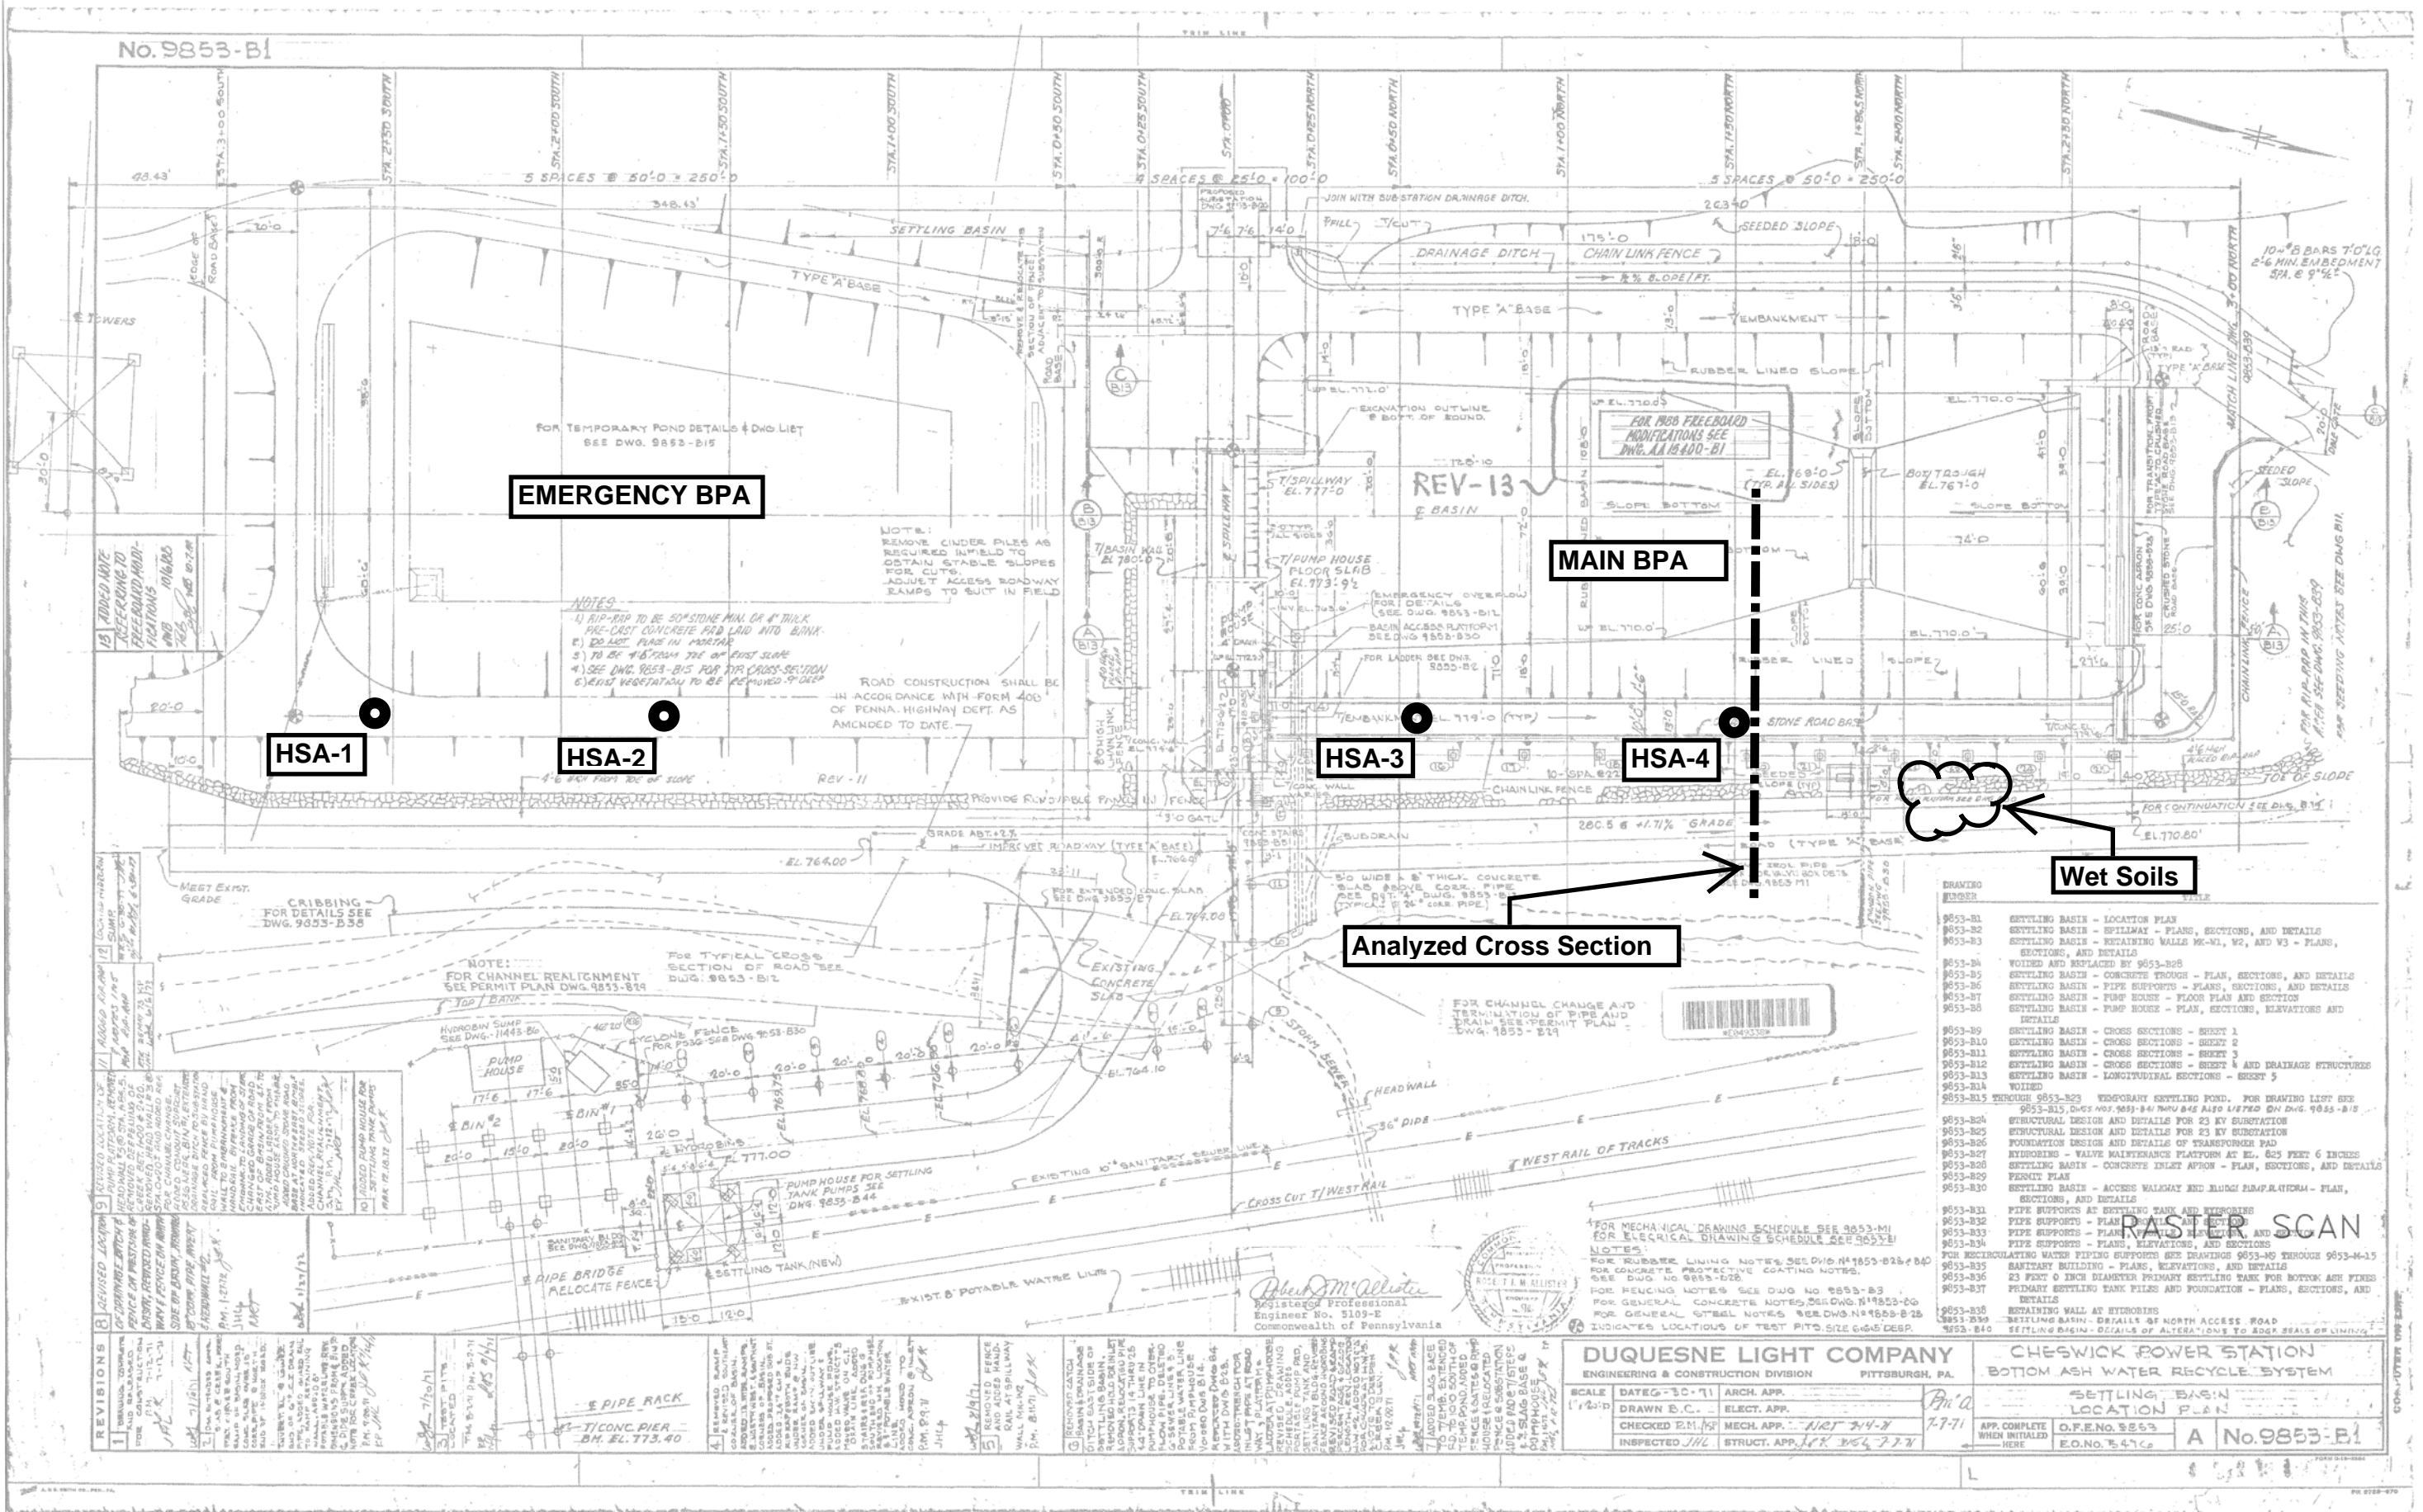
FIGURE

EPA's Coal Combustion Dam Inspection Checklist Form		Comments
Item Number	Item Description	
21	Seepage	<p>Wet soils were observed along the eastern slope of the main BAP. Location of wet soils is shown in Figure 1. Weather records, available from local weather stations, indicate that very little precipitation was recorded (&lt;0.05 inches) in the preceding three days before the site visit. Two possible causes of the presence of wet soils are:</p> <ul style="list-style-type: none"> <li>(i) the location may be a low point between the road and the berm that presents poor drainage. Ponded water was observed in the roadway north of the primary recycle pond at a location far enough away from the pond to eliminate the likelihood of seepage; the presence of this shallow standing water indicates that the water at the toe of the eastern slope could have originated from an earlier precipitation event.</li> <li>(ii) seepage is coming from the berm, along a path that was not identified in the nearby geotechnical boring (i.e., HAS-4). It is recommended that NRG continue to observe this location and note its condition after several days without precipitation.</li> </ul>

Geosyntec performed a stability analysis of the ponds' embankments. One representative cross section was selected for the analysis based on review of subsurface conditions, visual inspection, and pond geometry. The location of the selected cross section is at the main BAP, as shown in Figure 1. This section was selected because the embankment height at this location is the highest and the foundation soil had the lowest blow counts (SPT-N) obtained during the field investigation. In addition, the Emergency BAP is shallower than the main BAP (i.e., shorter embankment height), the emergency pond is operated during limited time (i.e., approximately one month a year), and the embankment material shows higher SPT-N value than the embankment material encountered at the main BAP; thus, the selected location at the main BAP

The geometry of the embankment was obtained from the design plans prepared by Duquesne Light Company dated July, 1971 (Figure 1). Because during visual inspection the existing slopes appeared to be steeper than the design slopes (i.e., the design slopes are approximately 1.5 Horizontal to 1 Vertical), Geosyntec also performed an additional analysis to evaluate the stability of the embankment assuming that it is steeper than designed. For purposes of performing a conservative analysis, existing outer slopes were modeled assuming a slope of 1 Horizontal to 1 Vertical.

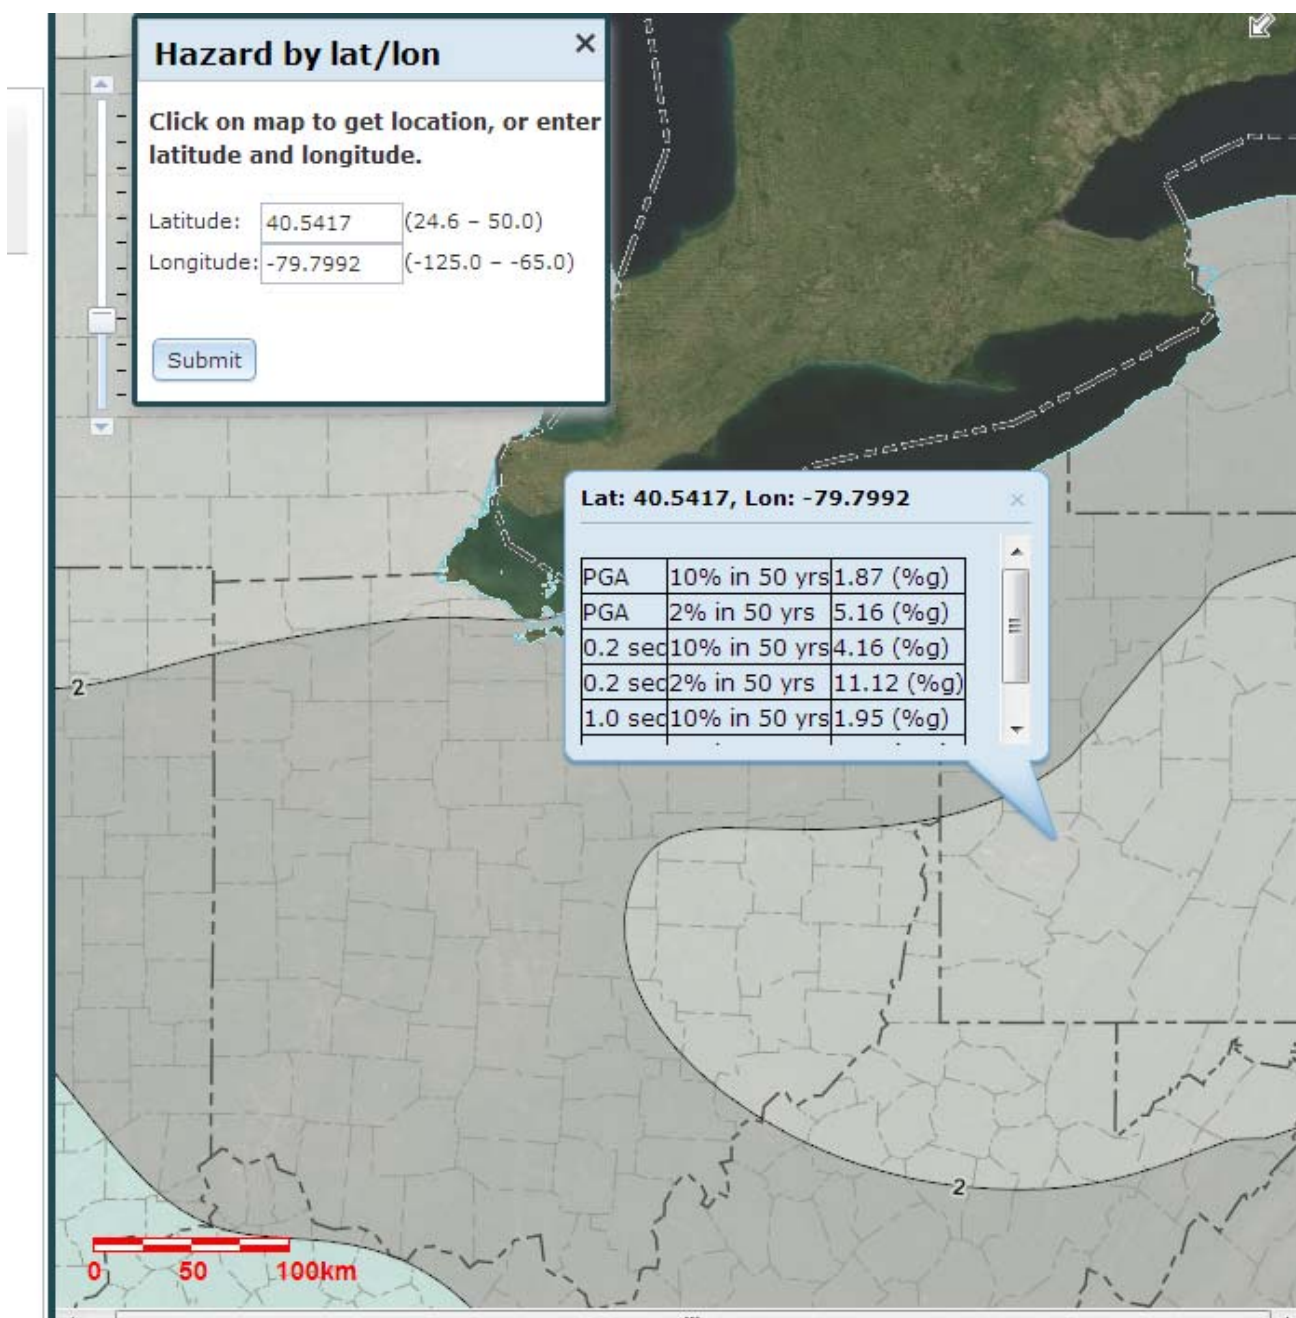
Figure 2. USGS Seismic Hazard Map

The maximum horizontal acceleration in bedrock for the Cheswick facility site is estimated to be 0.0516g (g is the gravitational acceleration), based on a seismic hazard map with contours of peak acceleration with 2% probability of exceedance in 50 years as indicated in Figure 2 [USGS, 2008]. This represents the peak ground acceleration in bedrock.
